Basic Imagery Interpretation Report

PETROVKA SHIPYARD, ORDER OF BATTLE SUMMARY

**STRATEGIC WEAPONS INDUSTRIAL FACILITIES
USSR
JANUARY 1969**

INSTALLATION OR ACTIVITY NAME		COUNTRY
Petrovka Shipyard, Order of Battle Summary		UR
UTM COORDINATES	GEOGRAPHIC COORDINATES	
NA	43-07-04N 132-20-25E	
MAP REFERENCE		
USATC, Series 200, Sheet M0291-6HL, 4th ed, Jul 64 (SECRET)

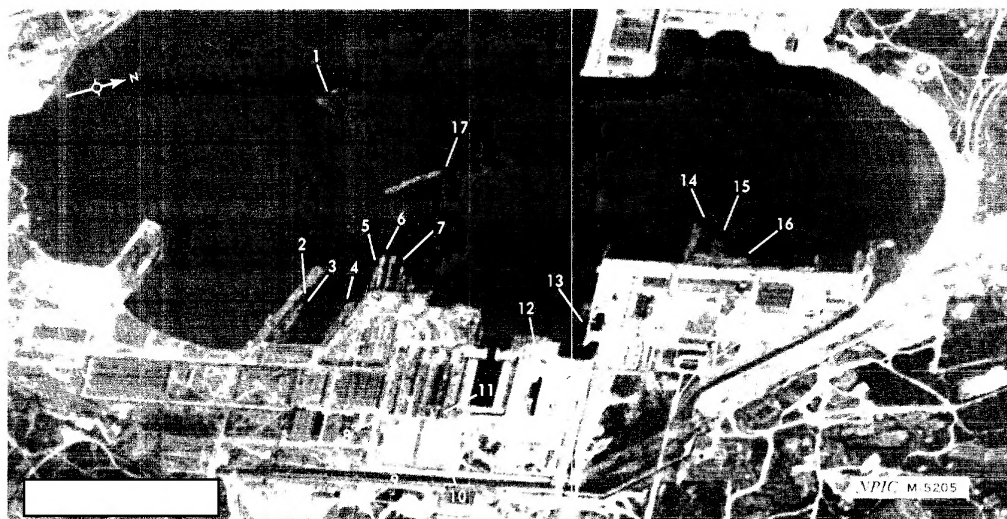
FIGURE 2. PETROVKA SHIPYARD

Table 1. Key to Figure 2.

Item	Description	Item	Description
1	Unidentified large submarine dead in the water with small unidentified vessel nearby	9	Possible small combatant on repair ways
2	Probable submarine	10, 11	Unidentified vessels on repair ways
3	Probable destroyer (DD)	12	Building under construction
4	Transporter dock occupied by vessel which cannot be identified or measured	13	Quay under construction
5	Small possible auxiliary	14	Probable Zeya YRSN
6	Probable auxiliary	15	Floating crane
7	Small probable combatant	16	Transporter dock, occupied, contents unidentified
8	Possible target barge on repair ways	17	Bulk. This vessel is grounded and has remained in this position for several years.

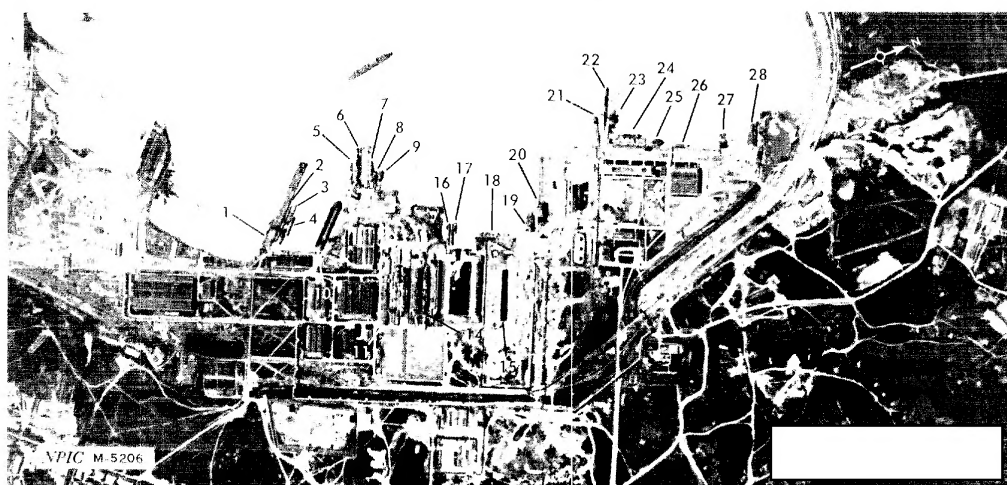
FIGURE 3. THE SHIPYARD

Table 2. Key to Figure 3.

Item	Description	Item	Description
1	Possible S-1 AGSS	17	Probable YRSN
2	Probable E-class SSGN	18	Unidentified auxiliary
3	Otlichnyy ODD	19	Floating crane
4	Support barge	20	Quay under construction
5	Small auxiliary	21	Probable Zeya YRSN
6	Probable 202A AFM/ASL	22	Possible E SSGN
7	Possible T-55 MSE	23	Floating crane
8	Probable tug	24	Unidentified auxiliary
9	Unidentified small vessel	25	Transporter dock, occupied by unidentified large SS.
10	Unoccupied transporter dock	26	B class SS. This is probably the second B class SS which was launched at Komsomolsk
11	Probable YAGT on repair ways	27	Floating crane
12	Large SS	28	Probable YR
13	Large SS		
14	Large SS		
15	Building under construction		
16	Probable YRSN

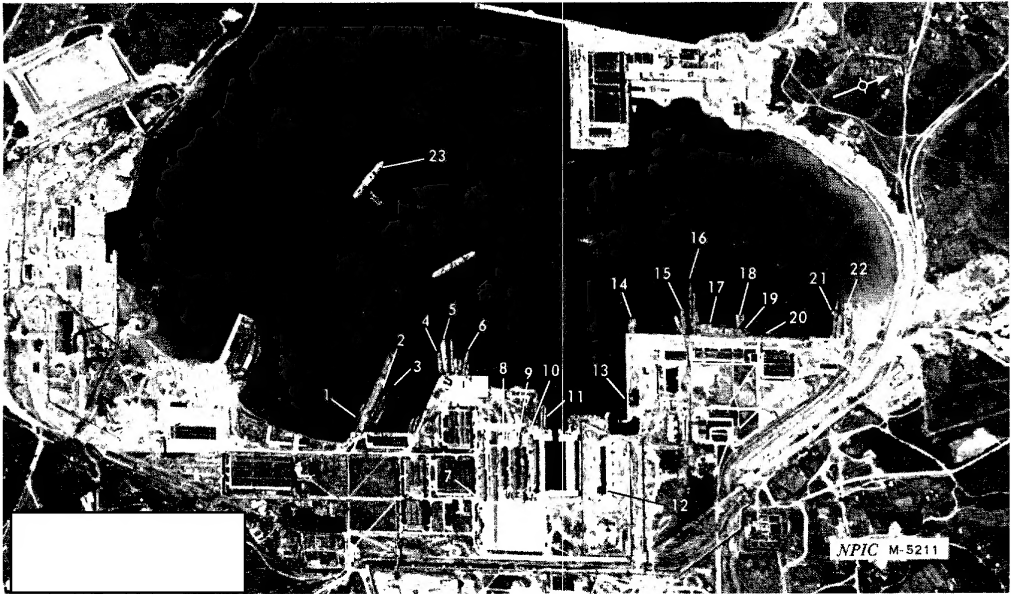
FIGURE 8. PETROVKA SHIPYARD

Table 6. Keyed to Figure 8.

Item	Description	Item	Description
1	Probable Medium SS	11	Rectangular-support barges. Two identical barges, probably functioning as RADCON/DECON vessels.
2	E SSGN	12	Building under construction
3	Probable DD	13	Quay under construction
4	Small auxiliary	14	Floating crane
5	Probable 202A AEM/ASL	15	Zeya YRSN
6	Probable T-55 MSF	16	E SSGN
7	YAGT on repair ways	17	Probable auxiliary
8	E SSGN on repair ways. The hull is scaffolded and the sail is still installed.	18	Floating crane
9	E SSGN on repair ways. The hull is scaffolded and the sail is not visible.	19	Transporter dock containing a large probable SS
10	E SSGN on repair ways. The hull is scaffolded and the sail is installed.	20	Probable B-class SS
		21	Probable Odiehnny AG
		22	Probable YR
		23	Medium freighter
